**Flood Control Project Maintenance
Levee Inspections**

Fall 2013 Levee Maintenance Deficiency Summary Report

Reclamation District No. 2063 Crows Landing

Levee Inspection Report By Mile - Fall 2013

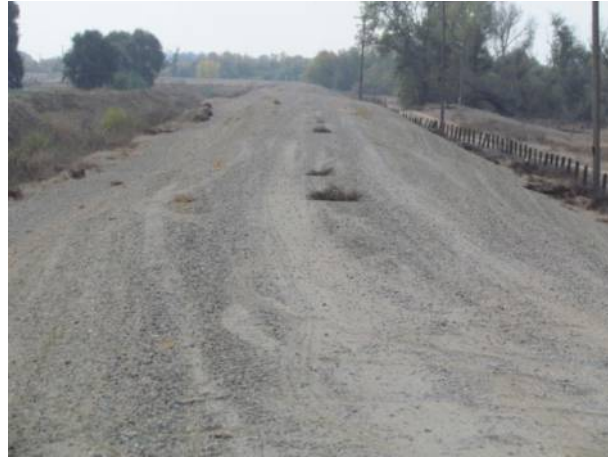
Levee Mile Report Line	5
Start Levee Mile	0.02
End Levee Mile	0.51
Location	Water Side
Category	Earthen Levee
Item	Vegetation

Looking south at typical view of waterside and landside slopes.

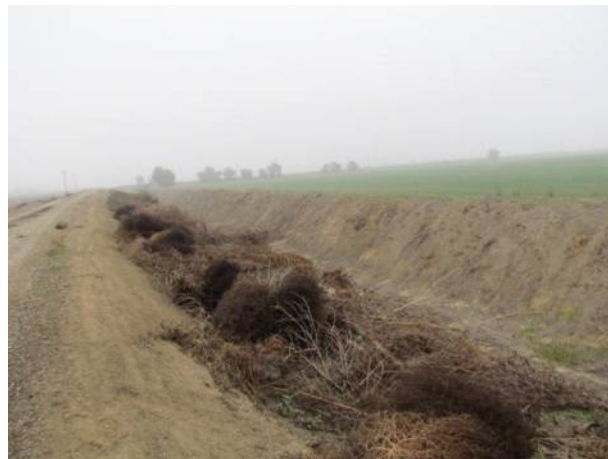
Levee Mile Report Line	7
Start Levee Mile	0.03
End Levee Mile	0.49
Location	Land Side
Category	Earthen Levee
Item	Encroachments

Looking north at ditch on landside berm and toe.

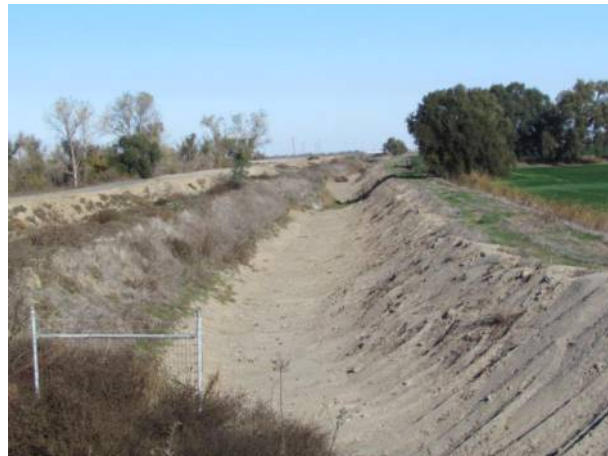
Levee Mile Report Line	7
Start Levee Mile	0.03
End Levee Mile	0.49
Location	Land Side
Category	Earthen Levee
Item	Encroachments

Looking south at canal-ditch at landside berm and toe.

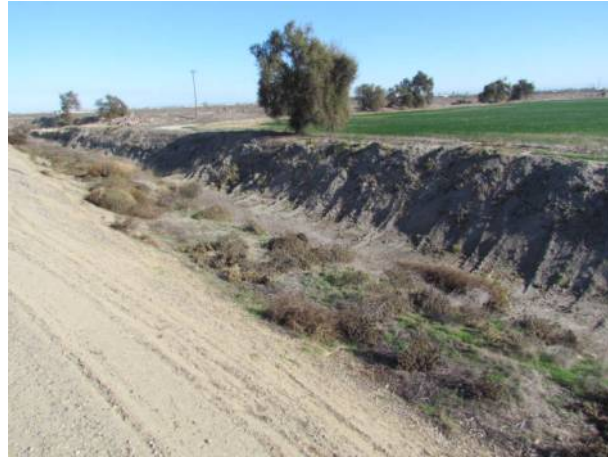
Levee Mile Report Line	7
Start Levee Mile	0.03
End Levee Mile	0.49
Location	Land Side
Category	Earthen Levee
Item	Encroachments

Looking northeast at canal-ditch on landside berm.

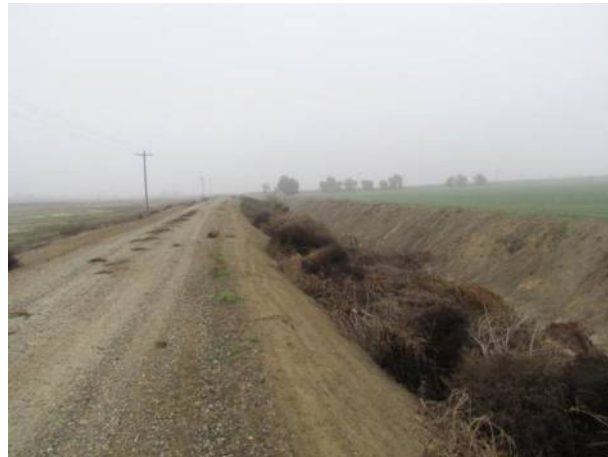
Levee Mile Report Line	8
Start Levee Mile	0.14
End Levee Mile	0.22
Location	Land Side
Category	Earthen Levee
Item	Encroachments

Looking north at prunings stacked on landside toe and berm.

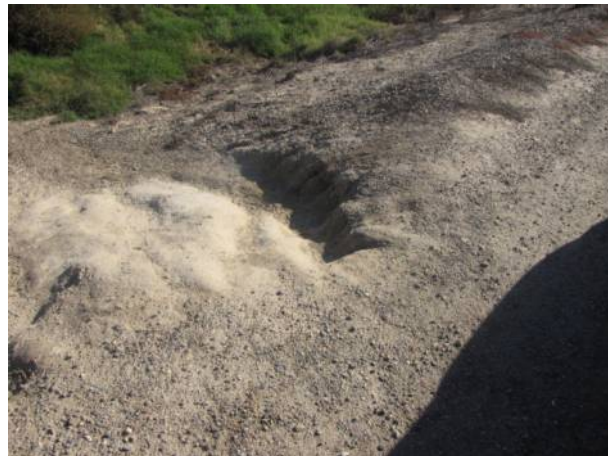
Levee Mile Report Line	11
Start Levee Mile	1.54
End Levee Mile	1.54
Location	Land Side
Category	Earthen Levee
Item	Slope Stability

Looking east at landside slope damage (six to eight inch erosion) by vehicle.

DWR ID: DWR_RD2063_01_s_2012_8									
11	1.54	1.54	Earthen Levee	Slope Stability	LS A/W Ma	S3 : Repair the levee slope damaged by vehicle traffic and prevent access where possible.	37.461762 ° -121.031822 °	37.461762 ° -121.031822 °	10 Y
DWR ID: DWR_RD2063_01_s_2012_10									
12	1.57	1.57	Earthen Levee	Animal Control	LS A/W Ma	A1 : Exterminate rodents and backfill and compact or grout burrows.	37.461322 ° -121.031785 °	37.461322 ° -121.031785 °	4
DWR ID: DWR_RD2063_01_s_2012_4									
13	1.69	1.69	Earthen Levee	Animal Control	LS A/W Ma	A3 : No rodents visible, but rodent burrows visible; need to backfill and compact or grout burrows.	37.459813 ° -121.032372 °	37.459813 ° -121.032372 °	11 Y
DWR ID: DWR_RD2063_01_s_2012_11									
14	1.95	1.95	Earthen Levee	Encroachments	LS A/W Ma	GA : Garbage Inspector Comments: Garbage at landside toe and berm.	37.456460 ° -121.033730 °	37.456460 ° -121.033730 °	117 Y

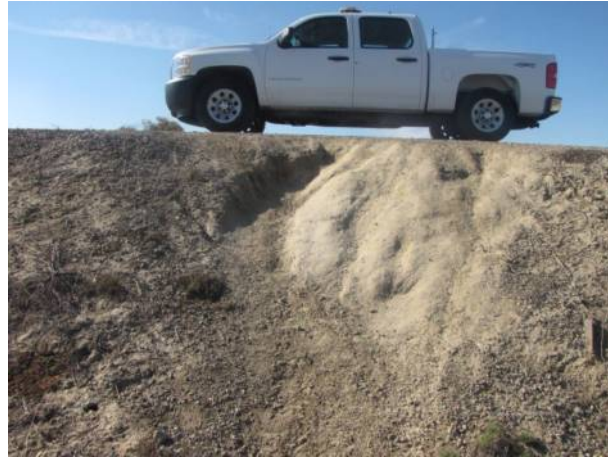
Levee Mile Report Line	11
Start Levee Mile	1.54
End Levee Mile	1.54
Location	Land Side
Category	Earthen Levee
Item	Slope Stability

Looking west at landside slope damage cause by vehicle traffic.

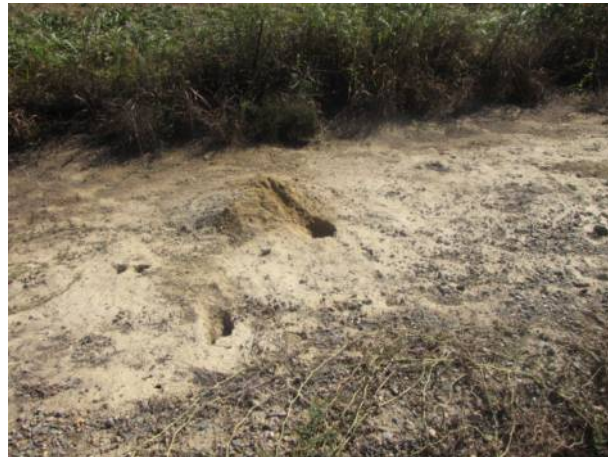
Levee Mile Report Line	13
Start Levee Mile	1.69
End Levee Mile	1.69
Location	Land Side
Category	Earthen Levee
Item	Animal Control

Looking east at squirrel holes on landside slope.

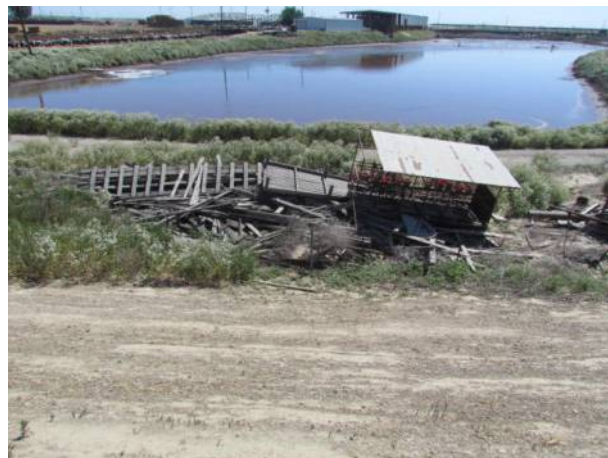
Levee Mile Report Line	14
Start Levee Mile	1.95
End Levee Mile	1.95
Location	Land Side
Category	Earthen Levee
Item	Encroachments

Looking east at garbage at landside toe.

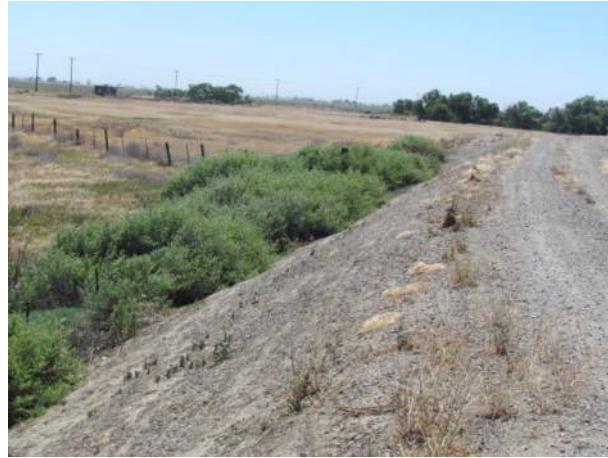
Levee Mile Report Line	16
Start Levee Mile	2.53
End Levee Mile	2.56
Location	Land Side
Category	Earthen Levee
Item	Vegetation

Looking south at dense vegetation on landside toe. (Before 2012)

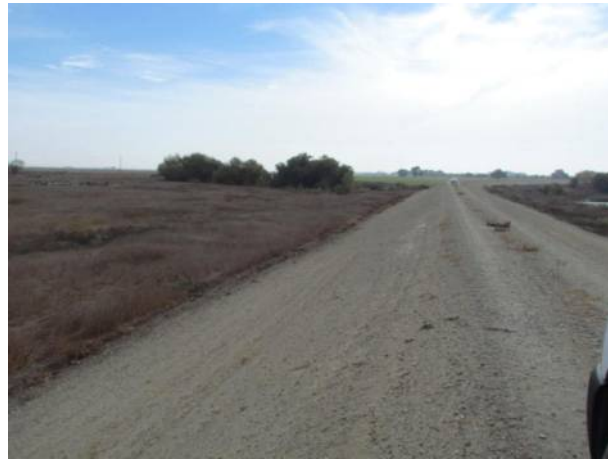
Levee Mile Report Line	16
Start Levee Mile	2.53
End Levee Mile	2.56
Location	Land Side
Category	Earthen Levee
Item	Vegetation

Looking south at vegetation removed from landward toe. (After 2013)

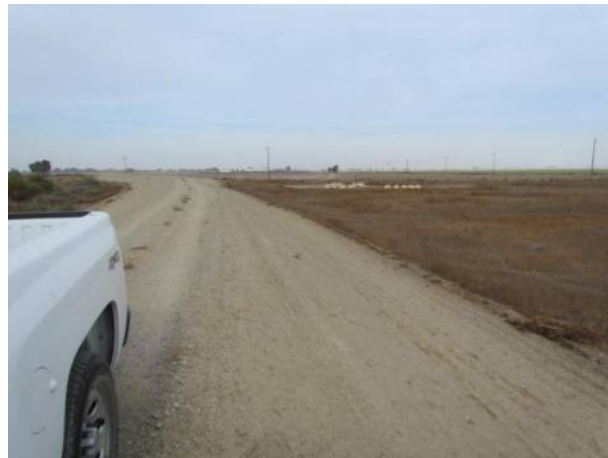
Levee Mile Report Line	16
Start Levee Mile	2.53
End Levee Mile	2.56
Location	Land Side
Category	Earthen Levee
Item	Vegetation

Looking north at removed vegetation from landward toe. (After fall 2013)

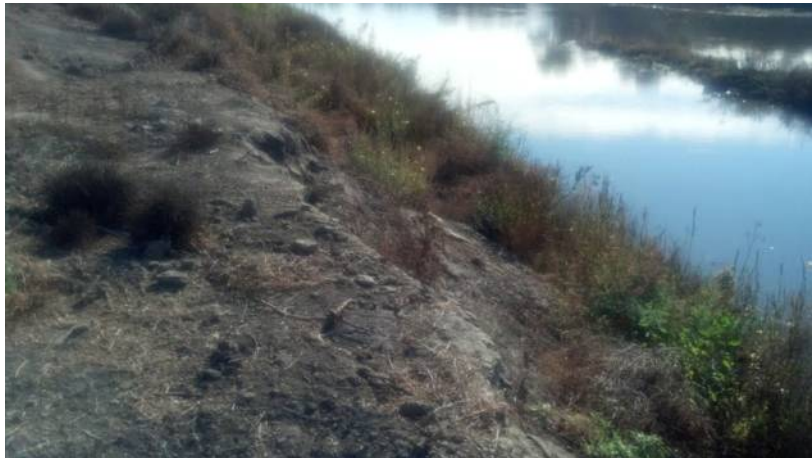
Levee Mile Report Line	19
Start Levee Mile	3.06
End Levee Mile	3.06
Location	Water Side
Category	Earthen Levee
Item	Erosion / Bank Caving

Looking southwest at river erosion at waterside slope and toe.

DWR ID: DWR_RD2063_01_s_2012_14									
19	3.06	3.06	Earthen Levee	Erosion / Bank Caving	WSA/W Ma	E2 : Schedule repair of erosion site prior to the next inspection. Inspector Comments: Several erosion sites located along waterside slope and toe approx. 100' plus feet long, 18-24 inches vertical cuts. Erosion site was repaired by district.	37.442816 ° -121.025421 °	37.442816 ° -121.025421 °	30 Y
DWR ID: DWR_RD2063_01_f_2012_30									
20	3.07	3.26	Supplemental	DWR Erosion Survey	WS C Ma	Inspector Comments: 08/30/2013: Site has been further enhanced by adding more broken concrete blocks to the river bank. The berm has been widened to approximately 50 feet along the site. 07/24/2012: Learned from the district that the upstream erosion has been repaired by placing broken concrete blocks. Visual inspection at the repaired site found no new erosion development. No significant change observed on the site at the downstream section of the repaired erosion site. 10/14/2011. This site was reported on Jan. 18. 2011. The first 100' of erosion appears to be a previous cut with fresh activity. At station 2+00 the district president indicated that 60 - 80' of material eroded. The remainder berm width is at least 32 ft from the levee toe. As the levee is not at risk at this time, the site is not rated, but needs to be closely monitored for possible erosion failure during the upcoming flooding season. [2013 Site ID:RD2063U01RM103.49]	37.442305 ° -121.022727 °	37.442305 ° -121.022727 °	19

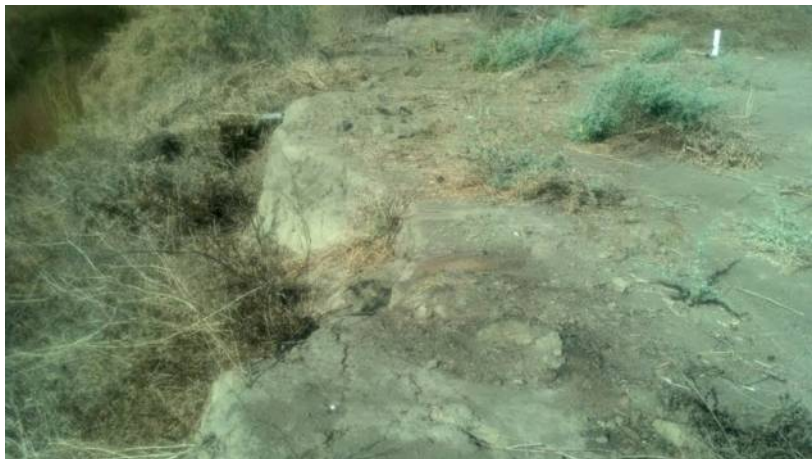
Levee Mile Report Line	19
Start Levee Mile	3.06
End Levee Mile	3.06
Location	Water Side
Category	Earthen Levee
Item	Erosion / Bank Caving

Looking northwest at river erosion at waterside slope and toe.

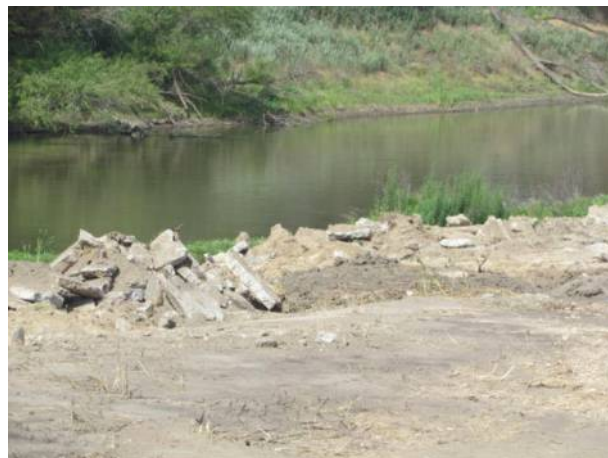
Levee Mile Report Line	19
Start Levee Mile	3.06
End Levee Mile	3.06
Location	Water Side
Category	Earthen Levee
Item	Erosion / Bank Caving

Looking southwest at repaired erosion site on waterward slope and toe.

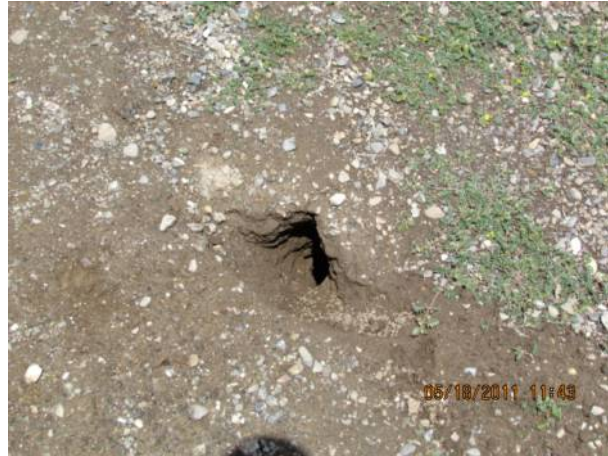
Levee Mile Report Line	23
Start Levee Mile	3.77
End Levee Mile	3.82
Location	Land Side
Category	Earthen Levee
Item	Animal Control

Looking at typical view of a squirrel hole on landside shoulder.

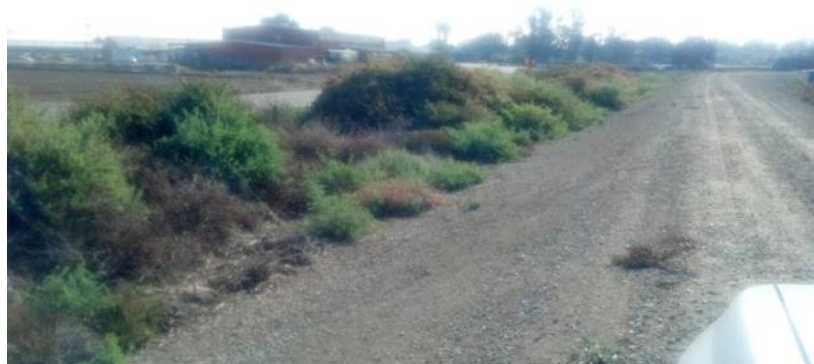
Levee Mile Report Line	24
Start Levee Mile	3.96
End Levee Mile	4.10
Location	Land Side
Category	Earthen Levee
Item	Vegetation

Looking southeast at dense vegetation along landside toe. (Before Fall 2012)

LMR No.	Levee Mile		Category	Item	Location	Rating	Action/Comment	GPS Latitude/Longitude		Issue No.
	Start	End						Start	End	
24	3.96	4.10	Earthen Levee	Vegetation	LS	M Ma	V2 : Remove the wild growth other than native grasses from the levee slopes.	37.434403 ° -121.014298 °	37.432653 ° -121.013327 °	17 Y
DWR ID: DWR_RD2063_01_s_2012_17										
25	4.67	4.67	Earthen Levee	Encroachments	LS	M En	PI : Pipe	37.429620 ° -121.005434 °	37.429620 ° -121.005434 °	6 Y
DWR ID: DWR_RD2063_01_f_2013_6										
26	4.68	4.68	Earthen Levee	Encroachments	WS	M En	CR : Crops Inspector Comments: Landowner planted grape vines and fruit trees and water tank on waterside berm without a permit from the CVFPB.	37.429638 ° -121.005348 °	37.429638 ° -121.005348 °	31 Y
DWR ID: DWR_RD2063_01_s_2012_31										
27	4.71	4.71	Earthen Levee	Trim / Thin Trees	LS	M Ma	T1 : Trim trees to at least five feet above ground level.	37.429892 ° -121.004768 °	37.429892 ° -121.004768 °	20 Y

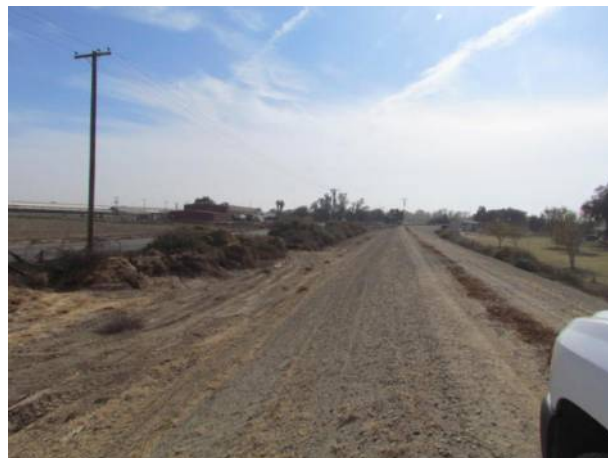
Levee Mile Report Line	24
Start Levee Mile	3.96
End Levee Mile	4.10
Location	Land Side
Category	Earthen Levee
Item	Vegetation

Looking south at removed vegetation from landward toe. (After fall 2013)

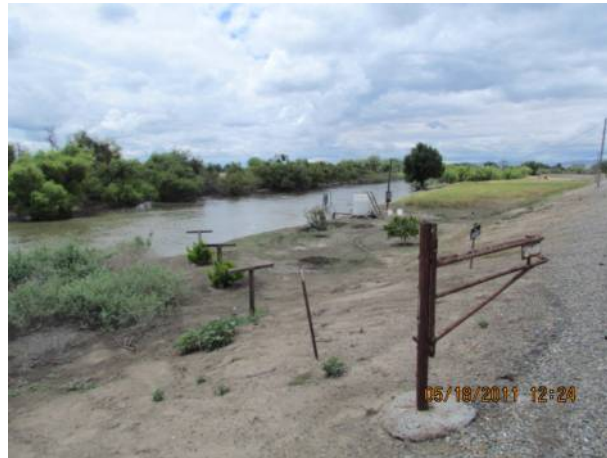
Levee Mile Report Line	26
Start Levee Mile	4.68
End Levee Mile	4.68
Location	Water Side
Category	Earthen Levee
Item	Encroachments

Looking south at grapevines and fruit trees on waterside berm.

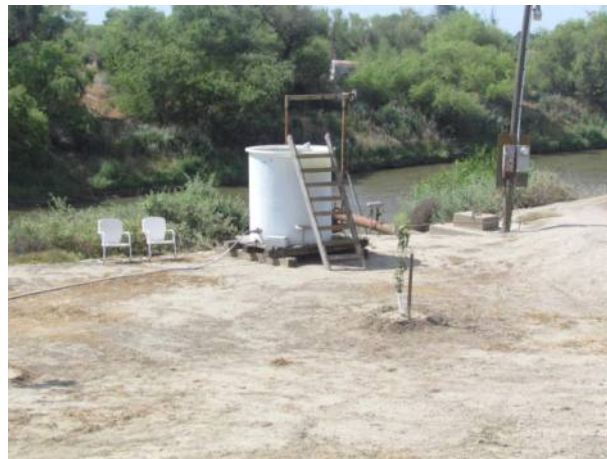
Levee Mile Report Line	26
Start Levee Mile	4.68
End Levee Mile	4.68
Location	Water Side
Category	Earthen Levee
Item	Encroachments

Looking west at water tank on waterward berm.

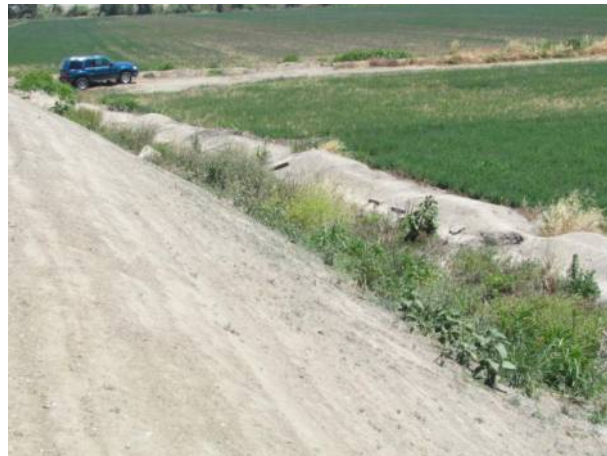
Levee Mile Report Line	28
Start Levee Mile	5.05
End Levee Mile	5.11
Location	Land Side
Category	Earthen Levee
Item	Encroachments

DWR ID: DWR_RD2063_01_s_2012_20										
28	5.05	5.11	Earthen Levee	Encroachments	LS A/W	M Ma	DT : Ditch Inspector Comments: Farmer removed irrigation ditch from landward toe.	37.428202 ° -120.999518 °	37.427518 ° -120.999362 °	119 Y
DWR ID: DWR_RD2063_01_s_2012_119										
29	5.16	5.16	Earthen Levee	Encroachments	WS	C Ma	MA : Material Inspector Comments: Concrete rubble with rebar	37.426887 ° -120.999368 °	37.426887 ° -120.999368 °	40 Y
DWR ID: DWR_RD2063_01_s_2013_40										
30	5.48	5.48	Earthen Levee	Erosion / Bank Caving	LS	U Ma	E2 : Schedule repair of erosion site prior to the next inspection. Inspector Comments: Erosion due to irrigation system at landward toe.	37.422827 ° -121.001788 °	37.422827 ° -121.001788 °	32 Y
DWR ID: DWR_RD2063_01_s_2012_32										
31	6.05	6.63	Earthen Levee	Vegetation	WSA/W	M Ma	V2 : Remove the wild growth other than native grasses from the levee slopes.	37.416235 ° -120.997563 °	37.411285 ° -120.998188 °	22 Y

Looking northeast at irrigation ditch at landside toe.

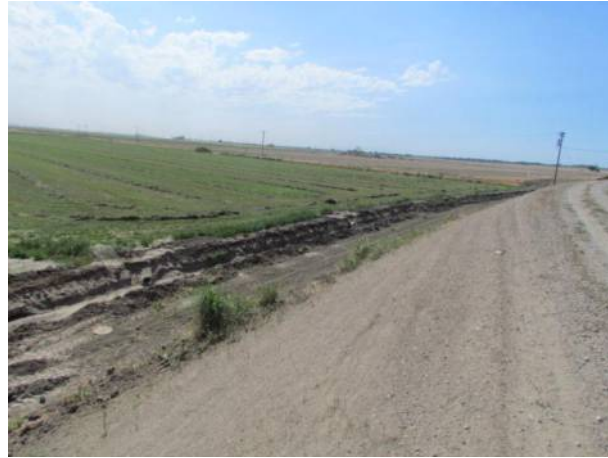
Levee Mile Report Line	28
Start Levee Mile	5.05
End Levee Mile	5.11
Location	Land Side
Category	Earthen Levee
Item	Encroachments
Looking northwest at irrigation ditch removed from landward toe.	
richard_f_20130930_025.JPG

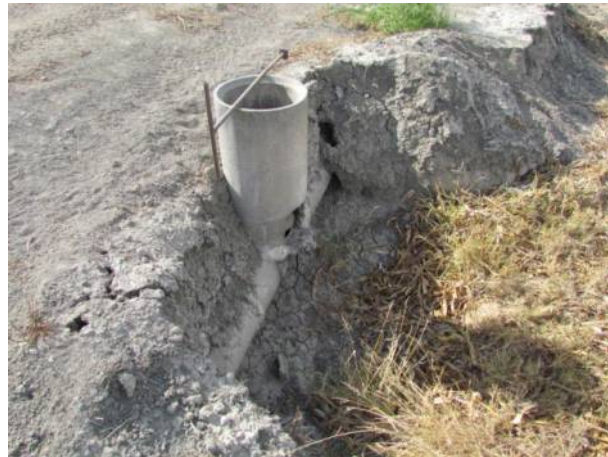
Levee Mile Report Line	30
Start Levee Mile	5.48
End Levee Mile	5.48
Location	Land Side
Category	Earthen Levee
Item	Erosion / Bank Caving
Looking north at irrigation system at landward toe.	
richard_f_20131108_161.JPG

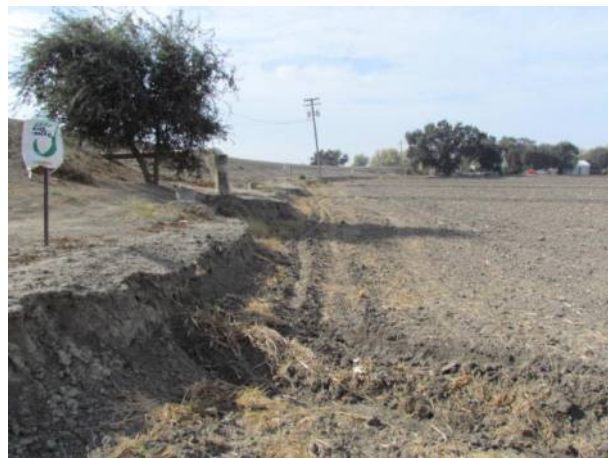
Levee Mile Report Line	30
Start Levee Mile	5.48
End Levee Mile	5.48
Location	Land Side
Category	Earthen Levee
Item	Erosion / Bank Caving
Looking south at several erosion sites at landward toe.	
richard_f_20131108_162.JPG

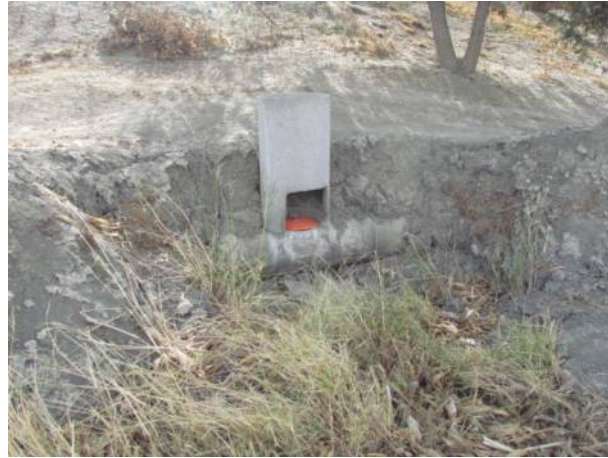
Levee Mile Report Line	30
Start Levee Mile	5.48
End Levee Mile	5.48
Location	Land Side
Category	Earthen Levee
Item	Erosion / Bank Caving

Looking west at erosion and irrigation system at landward toe.

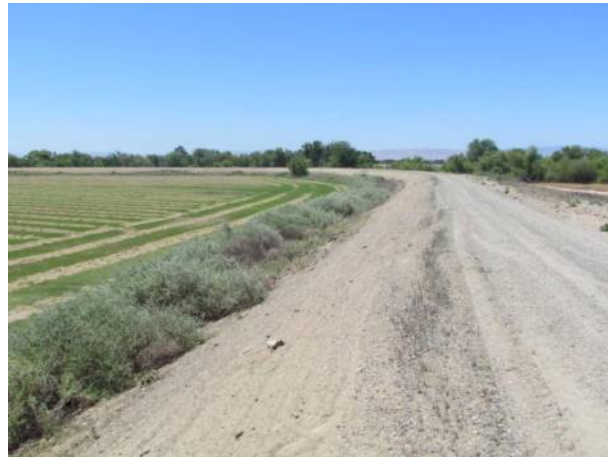
Levee Mile Report Line	33
Start Levee Mile	6.15
End Levee Mile	6.36
Location	Land Side
Category	Earthen Levee
Item	Vegetation

Looking south at dense vegetation on landside toe.

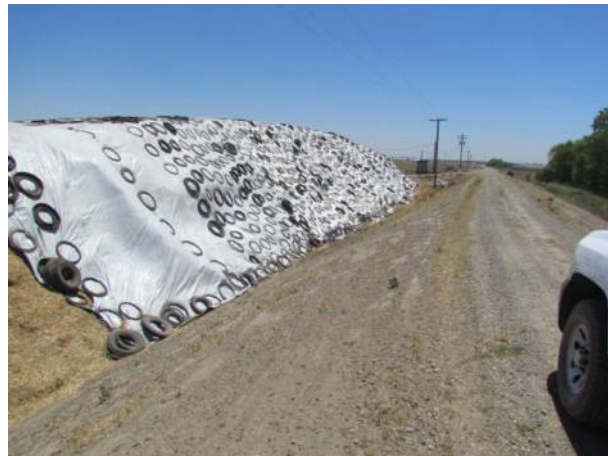
Levee Mile Report Line	41
Start Levee Mile	8.54
End Levee Mile	8.54
Location	Land Side
Category	Earthen Levee
Item	Encroachments

Looking south at hay stacked near landside toe.

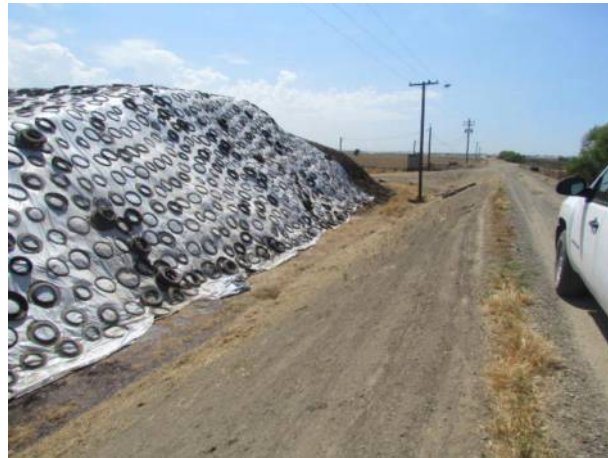
Levee Mile Report Line	41
Start Levee Mile	8.54
End Levee Mile	8.54
Location	Land Side
Category	Earthen Levee
Item	Encroachments

Looking northwest at hay pile still within easement.

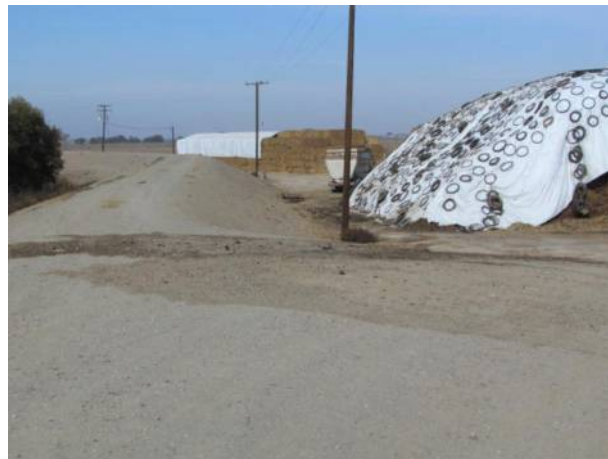
Levee Mile Report Line	41
Start Levee Mile	8.54
End Levee Mile	8.54
Location	Land Side
Category	Earthen Levee
Item	Encroachments

Looking north at hay stack outside the fifteen foot right-of-way. (Fall 2013)

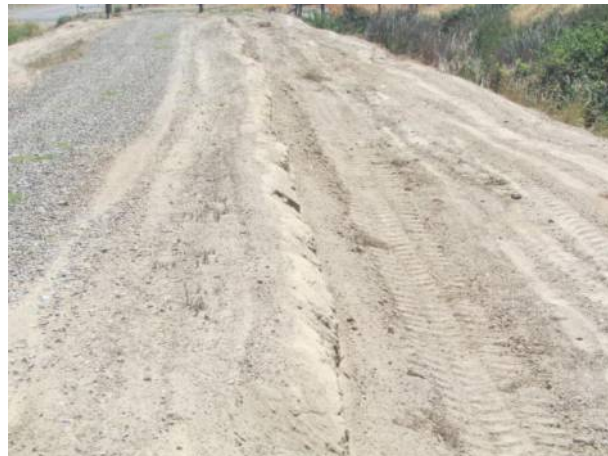
Levee Mile Report Line	43
Start Levee Mile	10.56
End Levee Mile	10.61
Location	Water Side
Category	Earthen Levee
Item	Erosion / Bank Caving

Looking north at erosion on waterward shoulder.
